TRINIDAD
School District Number 1

Facilities Maintenance Master Plan

Updated: February 2018

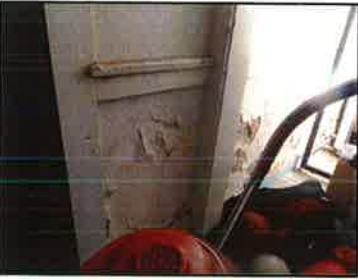
Water is infiltrating the below grade walls in the 1911 and 1922 buildings causing damage to interior finishes

- There is evidence of excessive water infiltration through the foundation walls of the 1911 and 1922 structures and potential damage to the foundation. It is likely that proper vapor protection needs to be installed around the foundation which will require significant excavation.

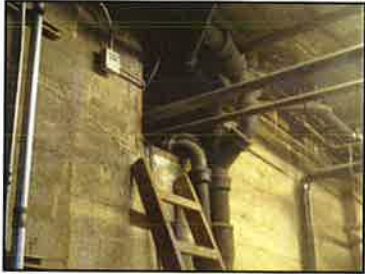
The underlying foundation walls still appear to be in good condition in the few areas where they could easily be seen

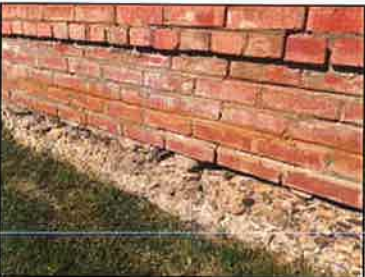
Signs of exterior foundational decomposition

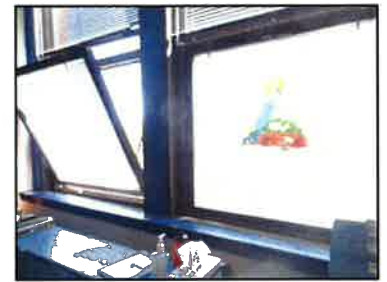
The windows in the 1911 and 1922 areas were replaced approximately 25 years ago. They are double-pane with aluminum frames and are in fair to poor condition. Many of the windows cannot lock open, and must be propped open with books if the occupants need fresh air.

The 1911 Middle School received double pane aluminum frame windows over 25 years ago, but many of the window frames are in poor condition and are no longer operable

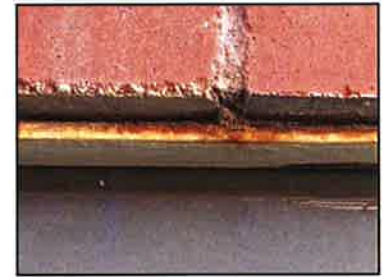
Extensive signs of deterioration of window lintels on 1911 portion of Middle School

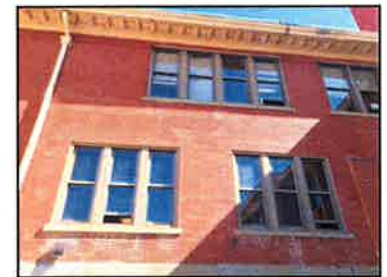
Windows are typically propped open for outdoor air to combat comfort issues

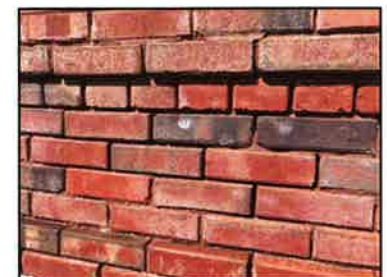
The 1911 and 1922 areas have a brick façade that is in dire condition. There is very little mortar left in the brick joints. Nearly the entire façade needs comprehensive repointing.

The brick façade of the 1911 and 1922 areas is in poor condition.

- The brick façade of the 1911 and 1922 exterior is in very poor condition. Comprehensive tuck pointing is recommended.
- The windows in the 1911 and 1922 buildings are in poor condition and should be replaced as it related to outside air supply and ventilation.
- Downspouts that direct storm water drainage all the way to the ground should be installed on the southeast wall of the auditorium. Adjacent surfaces should be regraded for proper drainage away from the building.
- The windows and glass block in the Park Street addition are in poor condition and need to be replaced.

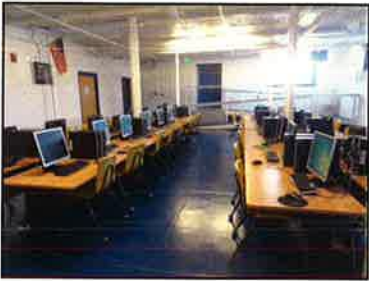
Despite the 1993 electrical upgrade, many of the classrooms still have an inadequate number of outlets

- The 1911 classrooms do not have sufficient outlets. Add more outlets to existing electrical circuits.
- The 1964 addition is still utilizing an electrical system original to its construction. This system cannot meet the current and future electrical needs of this portion of the building, and it does not meet current, acceptable electrical codes. It needs a comprehensive replacement.
- The backup power circuit of this building should be expanded to include the server room and any other critical loads.
- A modern and reliable generator needs to be installed.
- Due to the energy and utility savings potential, the existing fluorescent lighting systems is recommended to be replaced with more efficient LED systems.

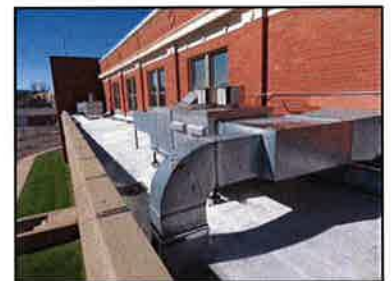
The 1922 gymnasium and lockers rooms are conditioned by rooftop furnaces that are in poor condition. The building does not have any cooling.

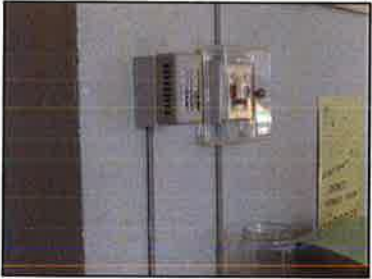
Ineffective pneumatic controls

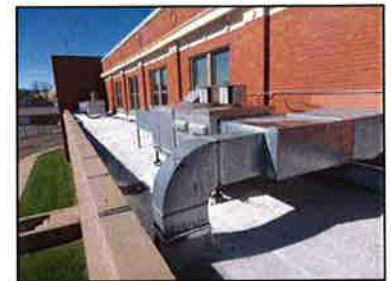
The 1922 gymnasium and lockers rooms are conditioned by rooftop furnaces that are in poor condition. The building does not have any cooling.

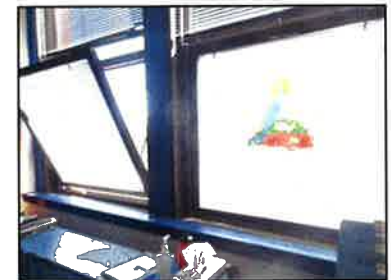
The 1911 Middle School received double pane aluminum frame windows over 25 years ago. Many of the window frames are in poor condition and can no longer open.

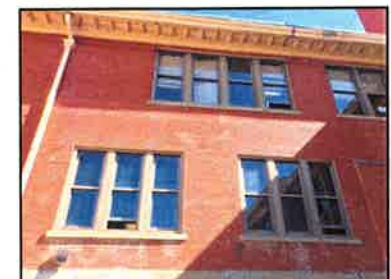
Windows are typically propped open for outdoor air to combat comfort issues

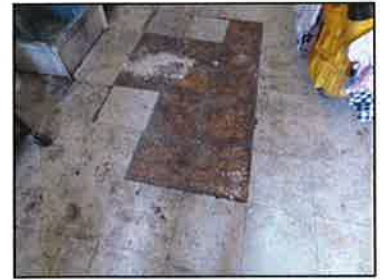
The subfloor in some of the 1911 rooms has been damaged and needs to be replaced.

- Replace the failing tile floors throughout the 1911 portion of the building with a more flexible flooring system.
- During the floor-replacement project, identify and replace all failed subfloors throughout the 1911 portion of the building.
- Replace the water-damaged floor in the science storage room and install a more appropriate shower floor and drain under the emergency shower.
- On the water-damaged ceiling joists above the light booth in the auditorium, check for mold, remediate if necessary, repair any structurally-significant water damage, and replace the affected decorative ceiling tiles.

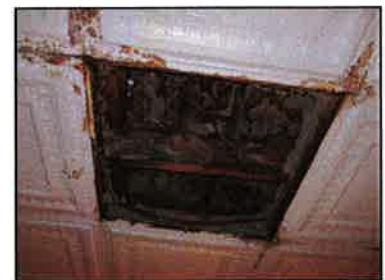
Water-damaged ceiling joists above auditorium

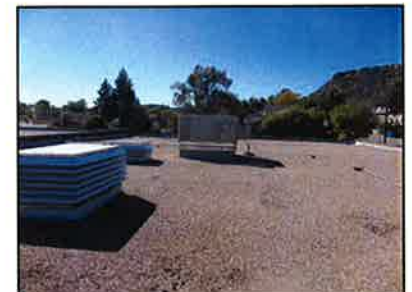
The ballasted built-up roof atop the High School A building is in adequate condition. The roof atop the High School B building is in poor condition and due for replacement.

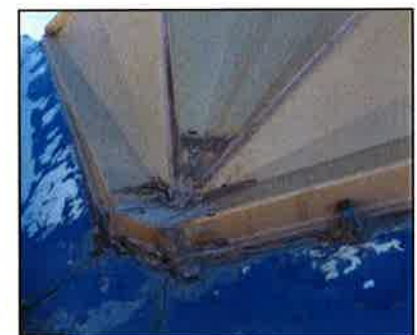
The dome is composed of aluminum panels which expand and contract throughout the year. Consequently, cracks form in the caulking between panel joints and leaks develop every year.

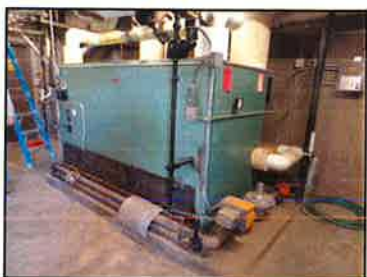
The B building is conditioned by hot water cabinet heaters. The boiler serving the hot water loop is in poor condition and is at the end of its reliable lifespan. The building has no cooling and poor ventilation

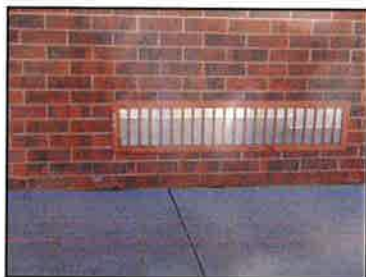
The outside air intakes of the heaters in the B building have been blocked off. This is likely because the system is undersized and cannot effectively heat the spaces with outside air.

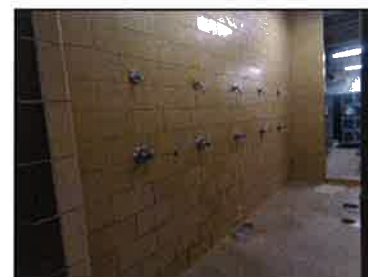
The gymnasium lockers rooms do not have a functional ventilation and exhaust system. Due to the high moisture content in these rooms, dangerous mold and bacteria strains can grow without proper ventilation

The exhaust fans for the gymnasium locker rooms and wrestling room are not working and there is currently no provision for these spaces to receive consistent ventilation air. Due to the high humidity that can arise in these spaces, this is a serious safety risk. Without adequate ventilation, dangerous strains of mold and bacteria can easily grow in these spaces. Two extremely large atmospheric boilers supply hot water to the building. Each boiler can provide 8,869 MBH of heat which is excessive for a building of only 43,000 square feet. These boilers should be replaced by a smaller, more efficient hot water plant. Additionally, the boilers are 40 years old and replacement parts are impossible to find. They have reached the end of their reliable lifespan.

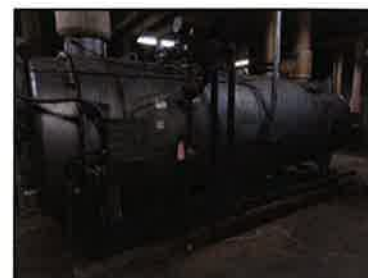
The large hot water boilers serving the building are 40 years old and are extremely inefficient. They need to be replaced with a smaller, more efficient boiler plant that is easier to maintain.

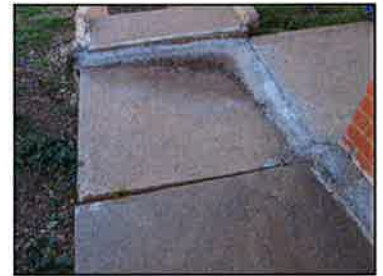
Exterior settling and cracking

- The two, old modular classroom buildings need to be demolished.
- The sidewalks around the northwest corner of the building need to be re-poured to properly shed water away from the building.

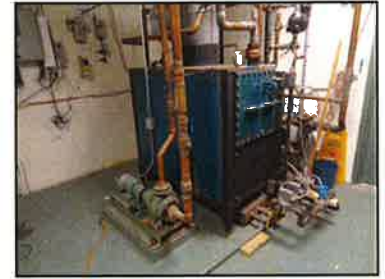
The boiler serving the hot water loop in the 1964 wing is over 25 years old. It is at the end of its recommended lifespan.

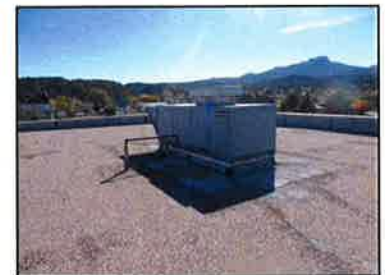
The rooftop furnace serving the gymnasium is at the end of its reliable lifespan and is due for replacement. (2002)

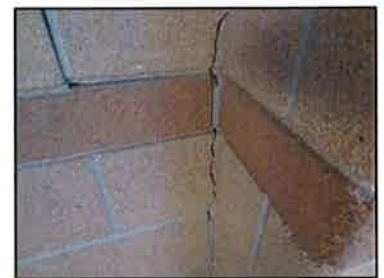
The settling of the concrete slab has damaged many of the interior walls in the school.

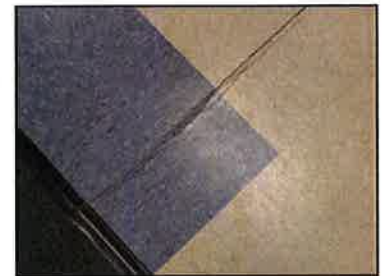
The settling slab has also produced a wide array of cracks in the floor.

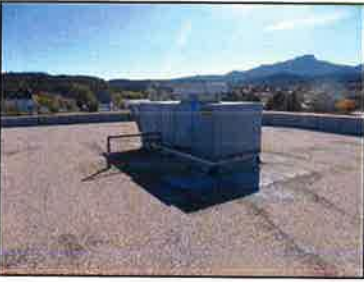
The packaged rooftop units serving the 2002 spaces are over 15 years old. They are due for replacement.

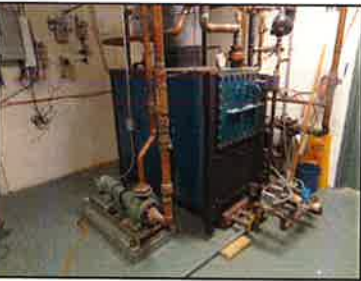
A dilapidated boiler serves the cafeteria and bathrooms in the 1964 building. The boiler is inefficient and difficult to maintain. It has reached the end of its 25 year ASHRAE recommended lifespan and is due for retirement. The hot water system should be replaced with a single gas/DX rooftop that conditions the cafeteria. The new high-efficiency unit will provide the cafeteria with cooling during the swing seasons and will be easier to maintain.

The boiler serving the Eckhart cafeteria is in poor condition and is due for retirement. A single gas/DX rooftop unit should be installed above the cafeteria to provide heating and cooling.

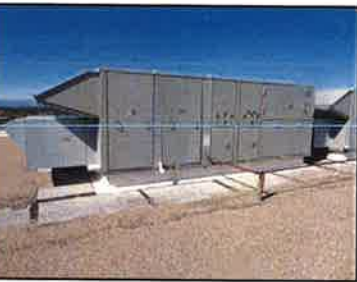
The rooftop units at Fishers Peak are over 15 years old. The district should budget for their replacement in the next 1 to 3 years.

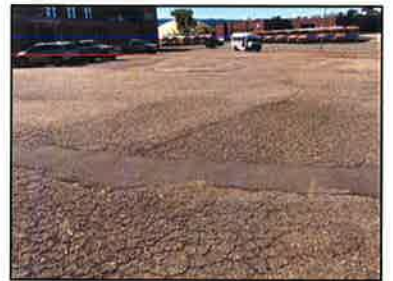
Typical deteriorated parking lot & asphalt conditions

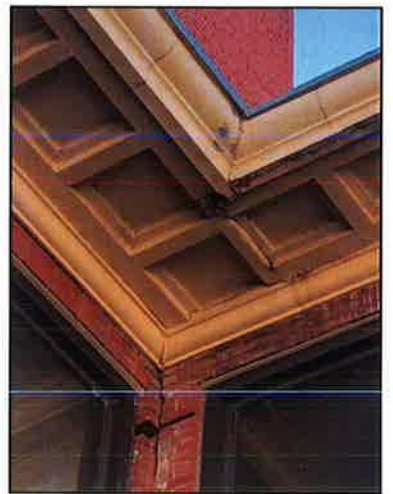
Deterioration from poor drainage

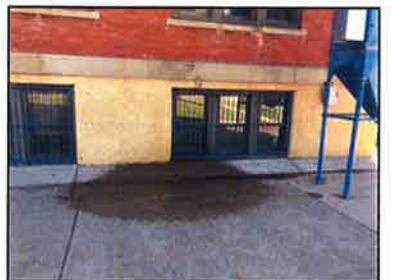
Poor site drainage

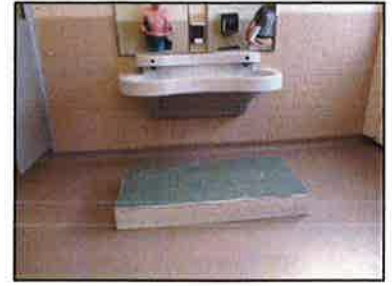
Bathroom accessibility issue
