TRINIDAD
School District Number 1

Facilities Maintenance Master Plan

Updated: February 2018

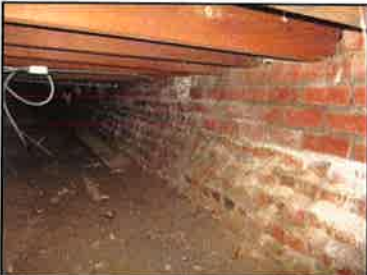
Interior crawlspace showing below grade walls and floor joists

In the limited area of the crawlspace visible through an access trapdoor in one of the classrooms in the southeast corner of 1911 portion of the building, there does not appear to be any serious water damage to the foundation wall. However, on all below-grade walls along the northwest side of this original building, along with the below-grade walls beneath the auditorium stage, there is extensive evidence of water infiltration and water damage of the interior plaster surfaces.

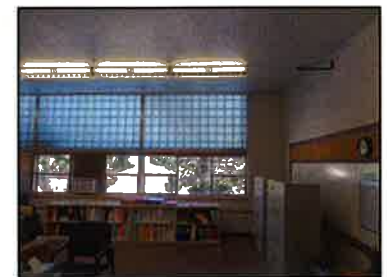
The 1964 addition has a brick façade that is still in adequate condition. The classrooms have original single pane aluminum framed windows that are in poor condition. Additionally, there is a large amount of glass block in the classroom exterior walls. Although great for natural light, the glass block results in poor thermal comfort in the spaces. The blocks get very cold in the winter and very hot in the summer.

The classrooms in the 1964 Park Street addition have a large amount of glass block

- The brick façade of the 1911 and 1922 exterior is in very poor condition. Comprehensive tuck pointing is recommended.
- The windows in the 1911 and 1922 buildings are in poor condition and should be replaced as it related to outside air supply and ventilation.
- Downspouts that direct storm water drainage all the way to the ground should be installed on the southeast wall of the auditorium. Adjacent surfaces should be regraded for proper drainage away from the building.
- The windows and glass block in the Park Street addition are in poor condition and need to be replaced.

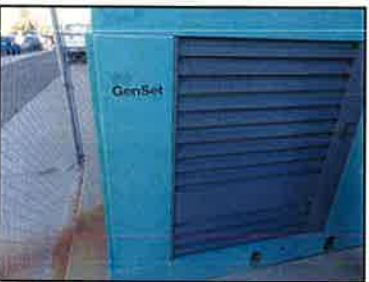
The generator was installed in 1993 and has been unreliable for the district. It was unable to start during the most recent power outage.

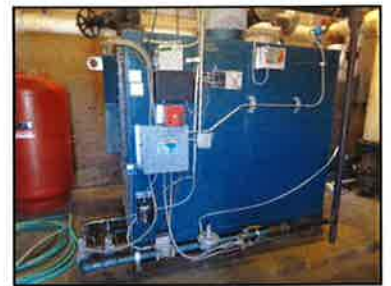
1993 atmospheric boiler

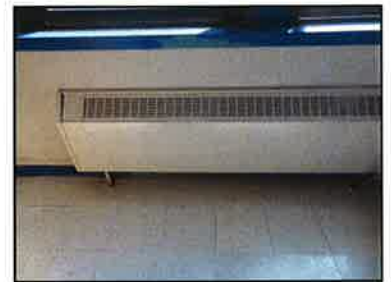
The classrooms in the 1911 building are conditioned by hot water baseboard convectors. None of the rooms have any cooling or mechanical ventilation.

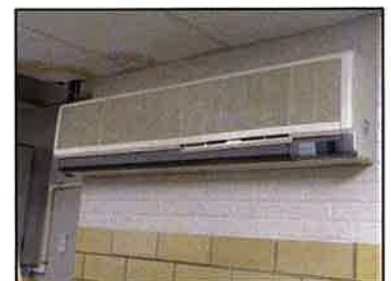
Ductless mini-split serving office areas

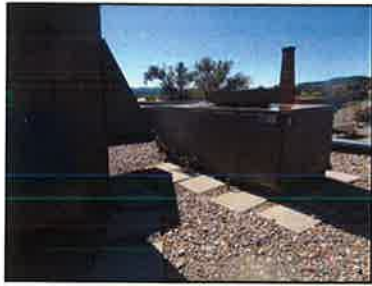
1964 Addition

The 1964 addition is conditioned by hot water baseboard convectors installed in 1993. Like the 1911 classrooms, the spaces in this building does not have cooling and relies on problematic windows for ventilation.

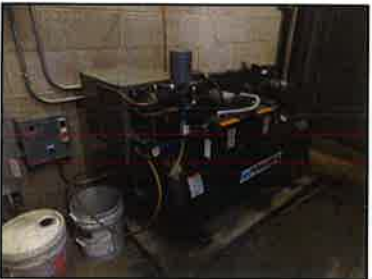
Air compressor for pneumatic controls

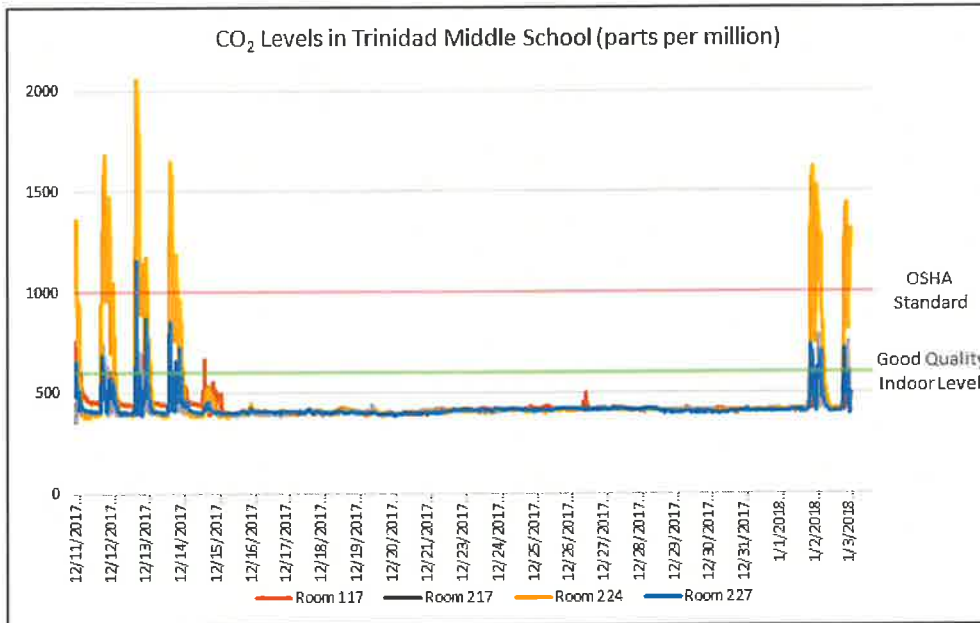
The sensors were placed in these rooms and recorded CO₂ levels every 15 minutes from December 11th, 2017 to January 3rd, 2018. The data they collected are presented in the below graph for easy visual evaluation:

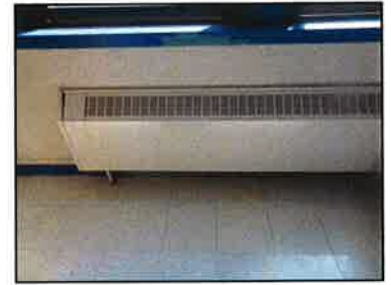
The classrooms in the 1911 building are conditioned by hot water baseboard convectors. None of the rooms have any cooling or mechanical ventilation.

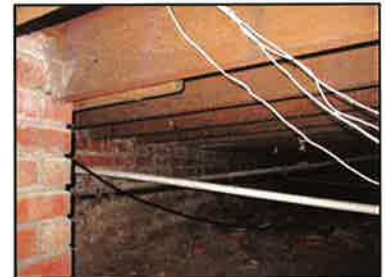
Joists seem to be in good condition

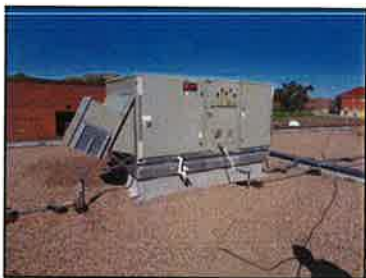
The outside air intakes of the heaters in the B building have been blocked off. This is likely because the system is undersized and cannot effectively heat the spaces with outside air.

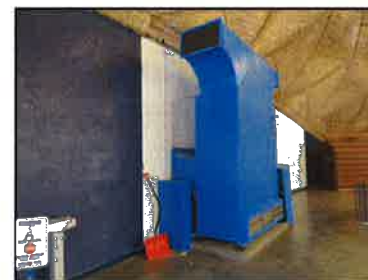
Large hot water air handlers located around the stadium perimeter heat the facility. There is no cooling in the building.

The district placed destratification fans in the room to mitigate this issue, but the maintenance staff no longer uses the fans because they routinely broke down and repairing them was too difficult due to their height and inaccessibility. The district should explore higher quality de-stratification fans that are more reliable. There is no cooling in the facility which makes the building uncomfortable during the spring and fall. There are large fans located around the building perimeter that can pull outside air into the building to provide some marginal cooling and ventilation, but this ad hoc solution is ineffective on very hot days.

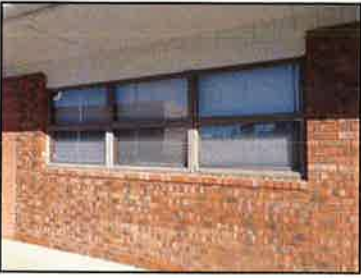
The 1964 wing has aluminum framed windows that are in serviceable condition.

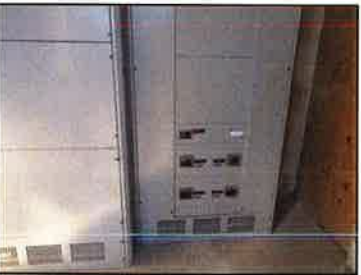
The new main distribution panel installed in 2002. It is in excellent condition and is providing the building with sufficient electrical capacity.

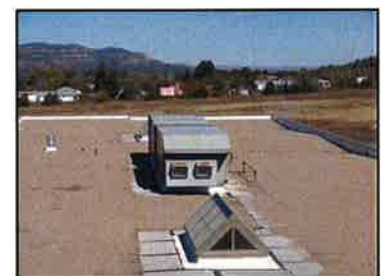
The building is protected by a ballasted built-up roof that is in fair condition. It is original to the 2002 construction.

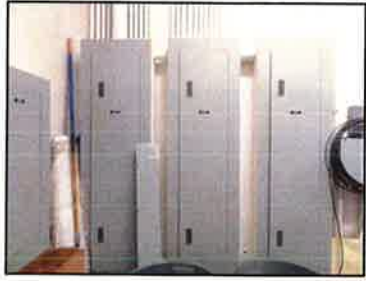
The electrical distribution in the building is in good condition. The MDP was sized properly and the classrooms have an appropriate number of outlets.

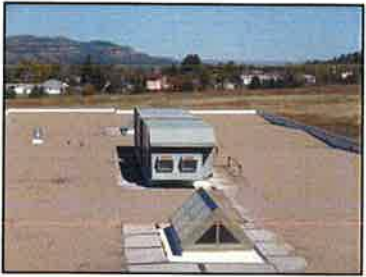
The classrooms are conditioned by packaged DX VAV air handlers located on the roof. Each room has a dedicated terminal VAV box with electric reheat.

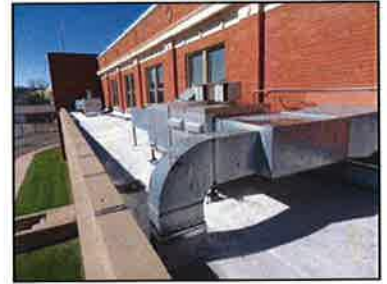
Dilapidated rooftop furnaces heat the 1922 gymnasium. They have reached the end of their serviceable life.

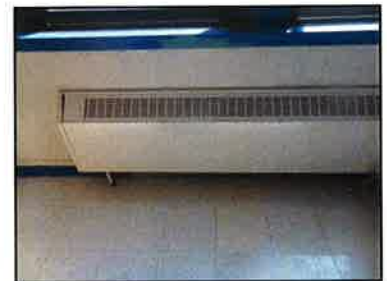
Hot water baseboard convectors heat most of classrooms and hallways in the school. The units do not provide ventilation air.

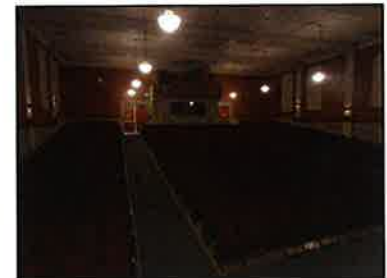
None of the spaces in the building, including the auditorium, have cooling. A packed play can become extremely uncomfortable without proper cooling.

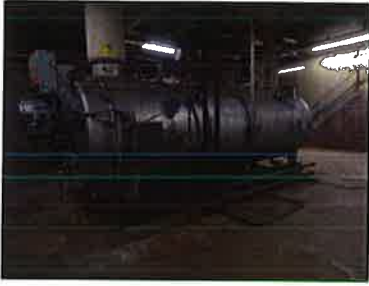
The High School Gym boilers are over forty-five years old. They are extremely inefficient and are difficult to maintain.

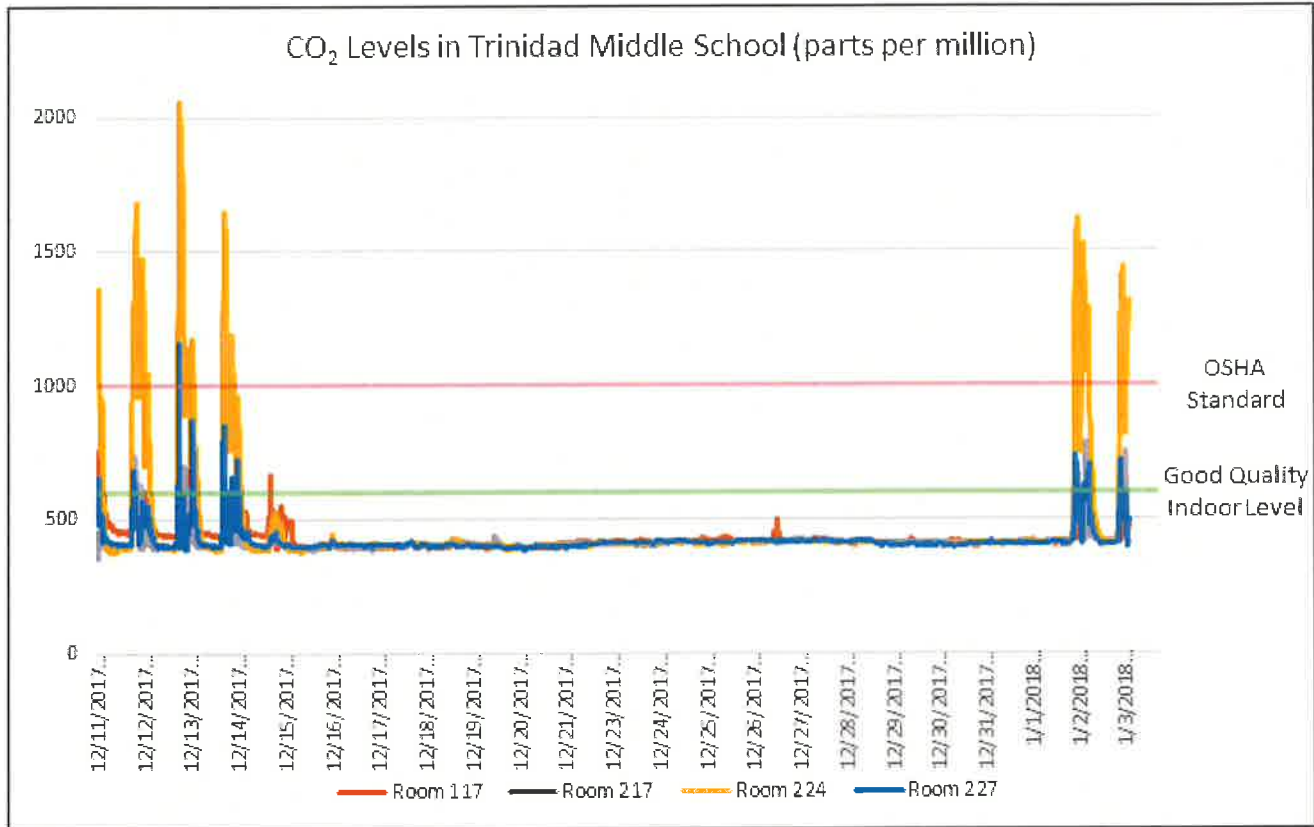
The sensors were placed in these rooms and recorded CO₂ levels every 15 minutes from December 11th, 2017 to January 3rd, 2018. The data they collected are presented in the below graph for easy visual evaluation:

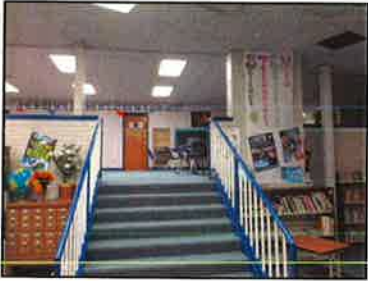
Site observations revealed that lighting fixtures in some of the public spaces remain on many times when spaces are not being occupied. Energy used for lighting could be significantly reduced by turning off lighting fixtures in these spaces when they are unoccupied.

Typical T8 Lighting Fixtures

Included in this measure is installation of occupancy sensors in the conference room, break room, and all four bathrooms. These publicly used rooms are spaces that can frequently have their lights remain on when the rooms are not occupied.

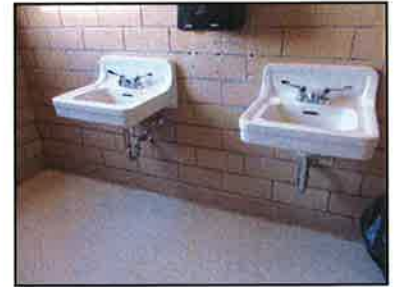
The plumbing fixtures in the building restrooms are standard flow type. The toilet flush valves were observed to be standard flush volume of approximately 1.6 gallons per flush, consuming marginally more than modern 1.28 gpf fixtures. The lavatory sinks have a standard 2.2 gallon per minute aerator. Urinals were observed to be 1.0 gpf.

Typical bathroom fixtures

Significant water savings can be achieved by retrofitting the existing urinal with 0.5 gpf valve diaphragms or replacing the entire fixture with 0.25 or 0.13 gpf fixtures. Modern low flow aerators can achieve 0.5 gallons per minute while still achieving adequate coverage – providing a cost-effective alternative to the current operation. Toilets can be replaced with 1.28 gpf fixtures.

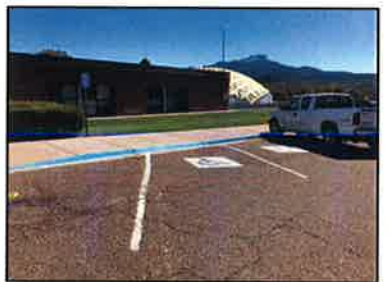
High School handicap parking spot

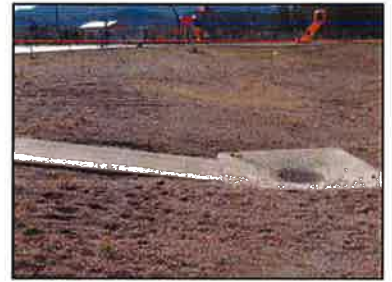
Onsite drainage
